Manhole Inspection Summary

Manhole # S21AA_017MH

Insp Date: **9/11/07 7:59 AM**

Location Address: **949 MOUNT-VINCENT**

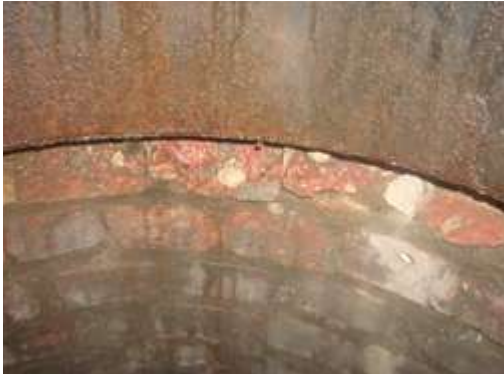
Defect 2

Condition: ☐ Sound ☐ Cracked ☐ Root Intrusion ☐ Loose Brick ☒ **Deteriorated**

DETERIORATED CORBEL

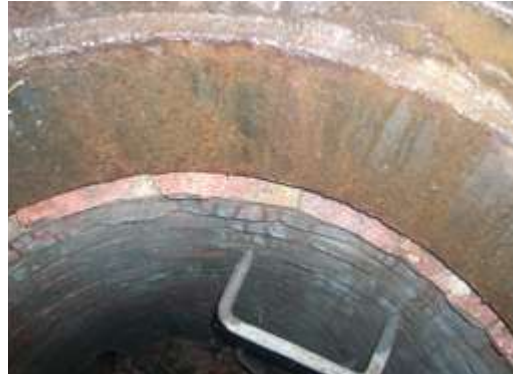
Defect 1

Offset: **1** (in.)

FRAME OFFSET

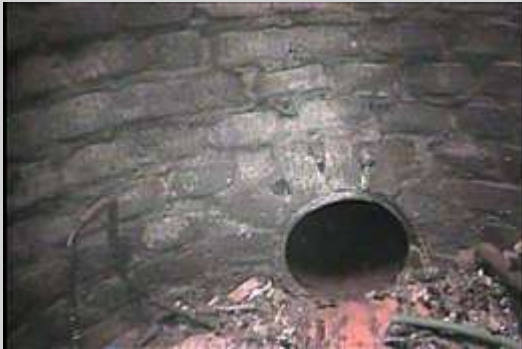
12 O'Clock Outflow

8 in. Circular Gravity Sewer
Pipe Out @ 12 O'Clock

Infiltration: **None** Pipe Seal Cond: **Sound**
